*Resource Conservation and Recovery Act (RCRA)
Follow-up Inspection Report*

Name: Cabo Rojo Wood Treating PLT, Corp.

Inspection Date: May 3, 2014

Project ID: CEPD-RCRA-09-0146

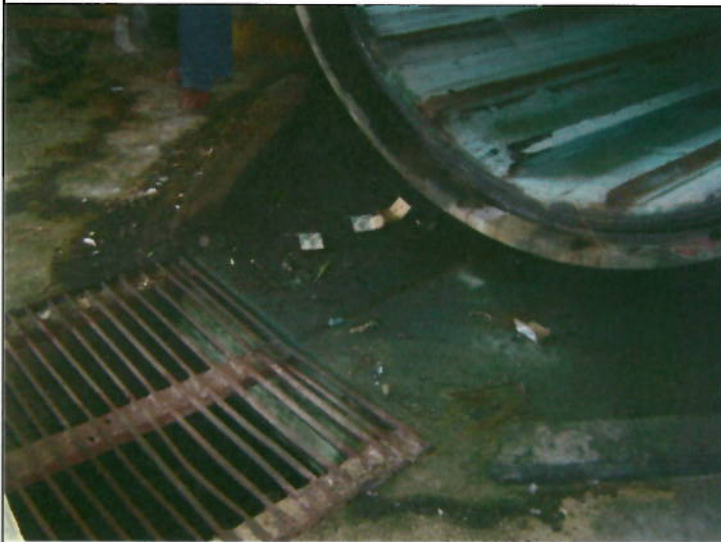
During the CEI, we noticed debris accumulated in front of the treatment cylinder (**Picture 1**). In addition, we observed a 5-gal container holding similar-material (**Picture 2**). We inquired Mr. Morales about this observation, he explained that these solids are generated after treatment, and are accumulated and removed in a weekly basis. According to Mr. Morales these residues are placed inside the 5-gal container to be disposed of. As he explained this procedure, we observed that the entrance to the hazardous waste accumulation area was blocked by a batch of treated wood. We inquired about this observation, and Mr. Morales agreed that it was unusual. In addition, he explained that the residues inside the accumulation area are generated from the drip pad operations and are disposed of at least once a year by Ashland. We approached the accumulation area, and noticed one 55-gal container and a 5-gal container open. The 55-gal container was overfilled (**Picture 3**), and labels were not observed over the containers.

Picture 1 — Debris and wood preservative stains in front of the treatment cylinder.

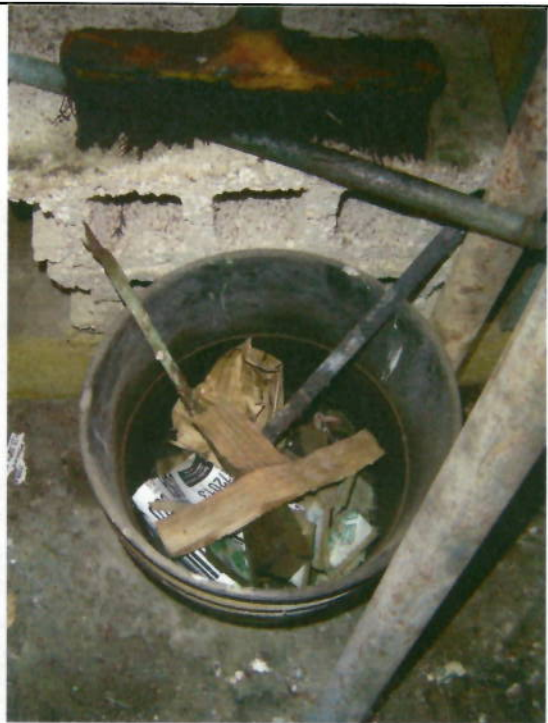
Picture 2 — 5-gal container with Debris derived from the wood preservation process.

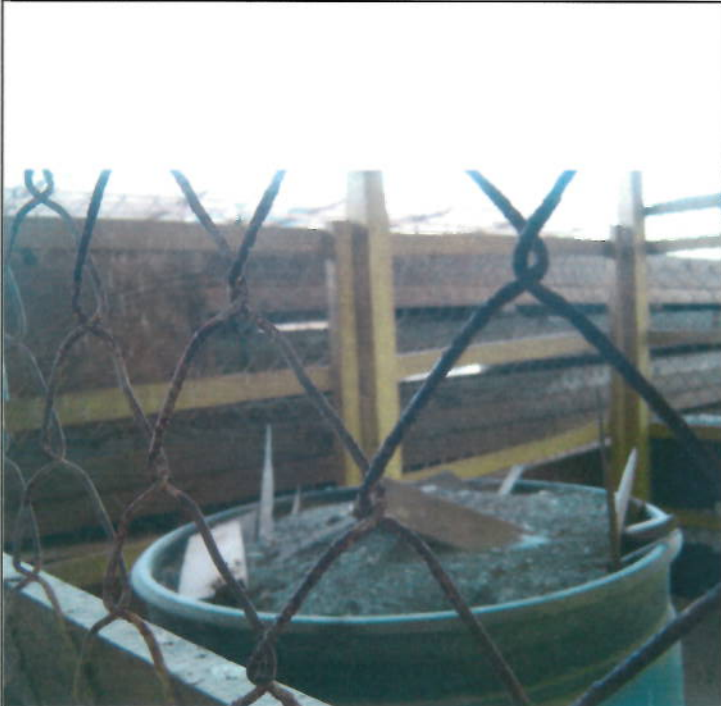
Picture 3 — Overfilled 55-gal container inside the accumulation area.

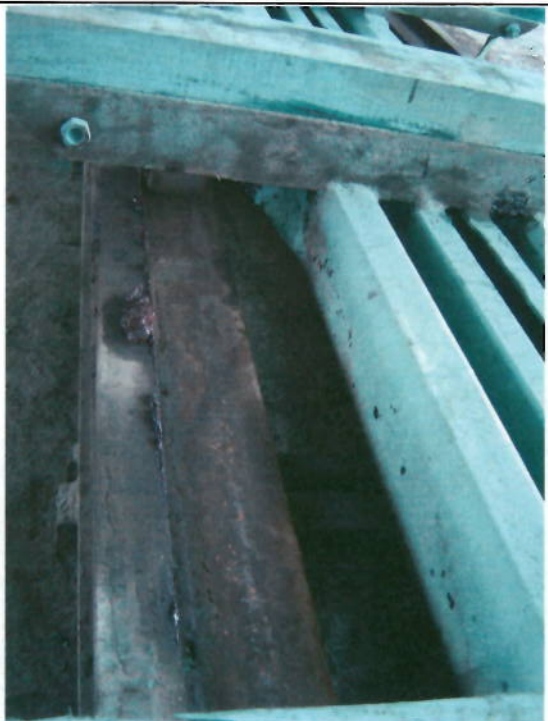
We proceeded to verify the condition of the drip pad's surface and noticed that it was deteriorated (i.e. cracks, sealant peeling) and covered with debris (i.e., treated wood chips, wood particulates, dust). Particularly, the area underneath the *treatment rail*, we observed that this area was severely deteriorated with debris (**Picture 4**).

At the time of the CEI, the area underneath the treatment rail was observed severely deteriorated: cracked and stained. The surface of the drip pad was not evenly sealed or covered, such that the entire surface where drippage occurs or may run across is capable of containing such drippage and mixtures of drippage and precipitation, materials, or other wastes while being routed to an associated collection system. However, the certified annual assessment, indicates that surface of the drip pad has a hydraulic conductivity of less or equal to 1×10^{-7} cm/second.

Picture 4 — View of the treatment rail. Signs of deterioration can be observed.

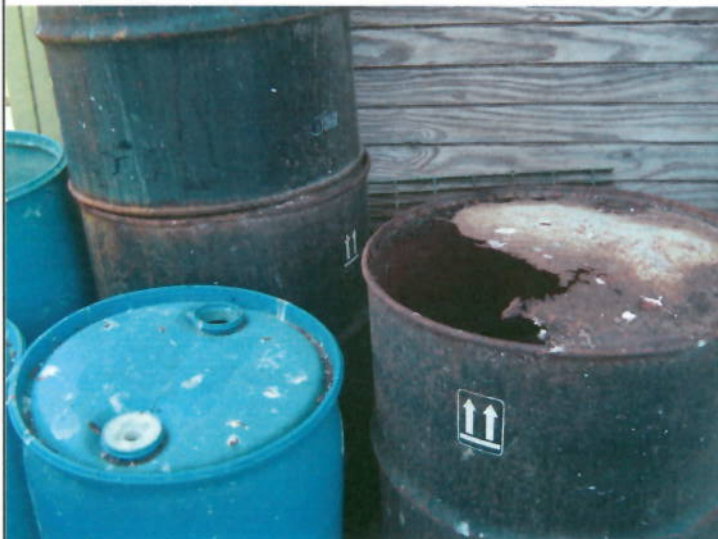
During the CEI, we observed several 55-gal severely corroded (**Picture 5**) containers along with one cubic yard containers stacked at the southeast area of the drip pad structure. Seven of 16 one cubic yard containers were observed with liquid inside of them, some of which were labeled as 2491 corrosive (**Picture 6**). The stack of these containers were unstable and could cause release of the unknown substance. We inquired about this situation, and Mr. Morales indicated that he was not sure about the source of the containers or its contents, but he mentioned that those containers are used to deliver wood preservative. We mentioned that similar conditions were found during the last inspections, and that immediate response to this situation was requested from the Facility. He indicated that actions to solve the situation will be taken.

Picture 5 — 55-gal containers at the lay down area.

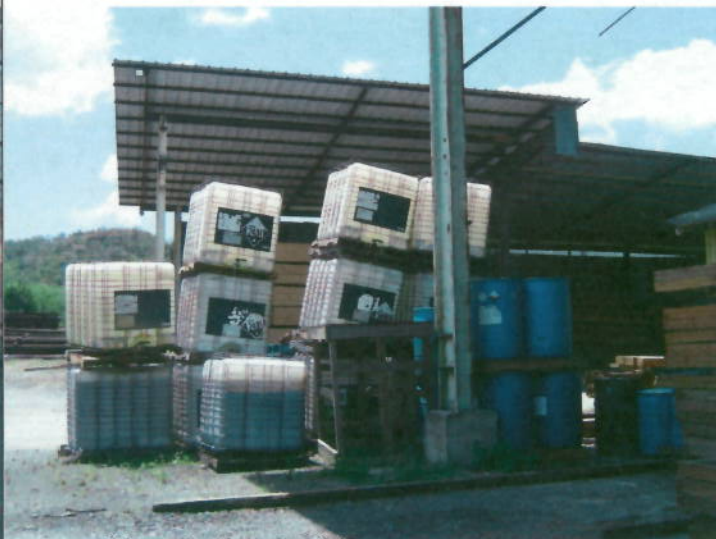
Picture 6 — Stacks of one cubic yard containers at the lay down area.

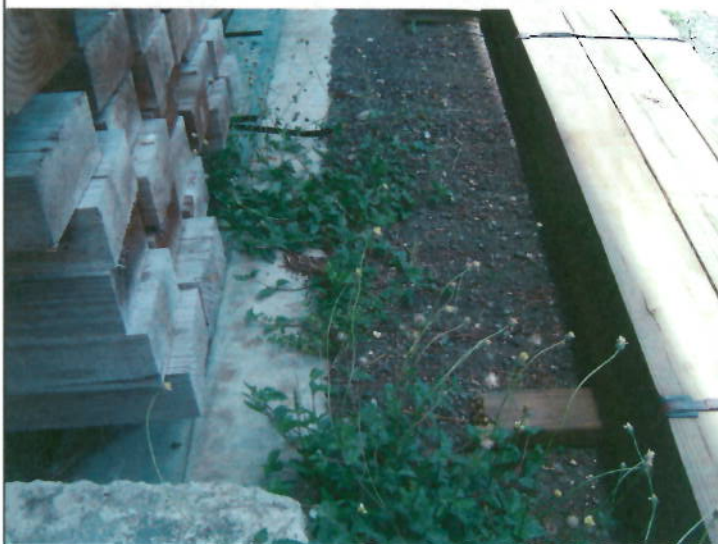
Later on the CEI, during the walkthrough of the lay down area, we noticed that the berm over the east side of the drip pad was lower than the other sides. In addition, treated wood was observed placed over such berm (**Picture 7**).

At the time of the CEI, we noticed that treated wood was placed over the curb or berm at the east side of the drip, which does not prevent run-off of the wood preservation solution and water from rain events.

Picture 7 — Drip pad's berm with treated wood placed over it.
